DEPARTMENT OF TRANSPORTATION

Quality Assurance and Source Inspection

Contract #: 04-0120F4Cty: SF/ALA Rte: 80 PM: 13.2/13.9File #: 1.28**WELDING INSPECTION REPORT****Resident Engineer:** Casey, William**Address:** 333 Burma Road**City:** Oakland, CA 94607**Report No:** WIR-026876**Date Inspected:** 14-Dec-2011**Project Name:** SAS Superstructure**OSM Arrival Time:** 700**Prime Contractor:** American Bridge/Fluor Enterprises, a JV**OSM Departure Time:** 1730**Contractor:** American Bridge/Fluor Enterprises, a JV**Location:** Jobsite**CWI Name:** As noted below**CWI Present:** Yes No**Inspected CWI report:** Yes No N/A**Rod Oven in Use:** Yes No N/A**Electrode to specification:** Yes No N/A**Weld Procedures Followed:** Yes No N/A**Qualified Welders:** Yes No N/A**Verified Joint Fit-up:** Yes No N/A**Approved Drawings:** Yes No N/A**Approved WPS:** Yes No N/A**Delayed / Cancelled:** Yes No N/A**Bridge No:** 34-0006**Component:** SAS OBG**Summary of Items Observed:**

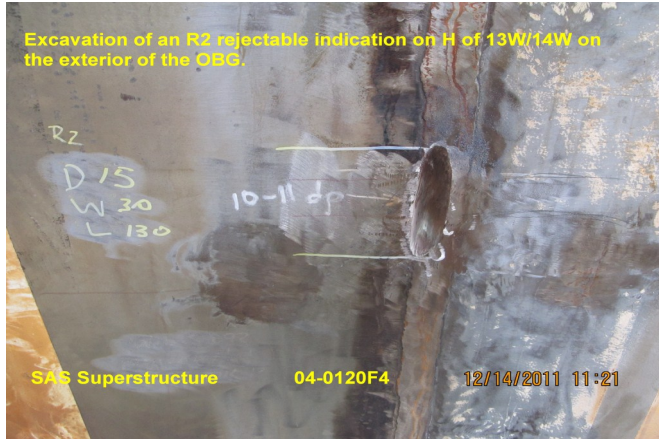
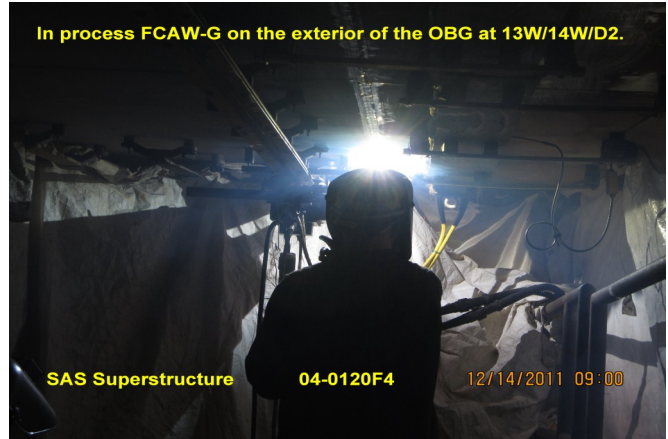
This QA Inspector observed at random intervals, ABF qualified welder Jeremy Dolman (ID 5042) performing the Flux Core Arc Welding with gas (FCAW-G) process utilizing a "Bug-O" motorized rail system with a magnetic base attached in the (4G) overhead position on the underside of bottom plate "D2", from 0mm – 7500mm at 13W/14W of the OBG. This QA Inspector observed QC Inspector William Sherwood monitoring the welding to ensure the welding parameters were in compliance pertaining to ABF-WPS-D15-3110-4. The parameters were recorded as (A=250/V=23.2/TS=174/HI=2.0).

inspection of the excavation on splice plate “H” section 13W/14W. The dimensions of the excavation were recorded as; y + 710 (depth/15mm, width/30mm, length/130mm). This QA Inspector observed that Mr. Sherwood found no rejectable indications.

This QA Inspector randomly observed ABF qualified welder Hua Qiang Huang (Welder ID 2930) performing the repair welding operation of an ultrasonic rejectable indication as per the Shielded Metal Arc Welding (SMAW) process in the (3G) vertical position on OBG splice plate “H” 13W/14W. The excavated area was as noted as a Critical Weld Repair (CWR) and at the time of this report; the procedure is pending the Engineer’s approval. This QA Inspector observed QC Inspector Mr. William Sherwood verify that the preheat temperature was at the minimum of 325 Degrees F and that the welding parameters (Amps, Volts, and Travel Speed) were in accordance with WPS D1.5 - 1004 Repair.

This QA Inspector randomly observed ABF welder Wai Kit Lai (Welder ID 2953) performing the repair welding operation of an ultrasonic indication as per the Shielded Metal Arc Welding (SMAW) process in the (4G) overhead position on “D2” at y + 7750. This QA Inspector observed the use of E7018-H4R electrodes and QC Inspector William Sherwood verify the preheat temperature and that the welding parameters (Amps=135) were in accordance with WPS D1.5–1004- Repair. The welding parameters observed at this location appeared to be in general compliance with approved WPS and the contract specifications. Upon completion of the repair, a thermal induction blanket was placed over the area for Post Weld Heat Treatment (PWHT) at 450 degrees F for 1 hour.

This QA Inspector randomly observed QC Inspector Mr. Jesse Cayabyab perform a R1 ultrasonic inspection of the repaired area on OBG bottom plate section 13W/14W at weld location D1. This QA Inspector observed that Mr. Cayabyab detected three (3) rejectable ultrasonic indications at “Y” location 7240 mm (depth/17mm, length/15mm), “Y” 7670 (depth/21mm, length/20mm) and “Y” 8640 (depth/12mm, length/120mm). The deck plate section is 30 mm to 35 mm thick. These locations were within the original indication #13 Critical Weld Repair (CWR). This QA Inspector noted that at the time of this report; the procedure is pending the Engineer’s approval.
